LITTLE SCHUYLKILL DAM  
SCHUYLKILL COUNTY, PENNSYLVANIA  
NATIONAL I.D. NO. PA-00655

⑥ National Dam Inspection Program. Little Schuylkill Dam (National I.D. Number PA-00655), Schuylkill River Basin, Schuylkill County, Pennsylvania. Phase I Inspection Report.

Name of Dam: Little Schuylkill Dam  
County Located: Schuylkill County  
State Located: Pennsylvania  
Stream: Little Schuylkill Creek  
Coordinates: Latitude 40° 50.2' Longitude 76° 0.3'  
Date of Inspection: 23 May 1978

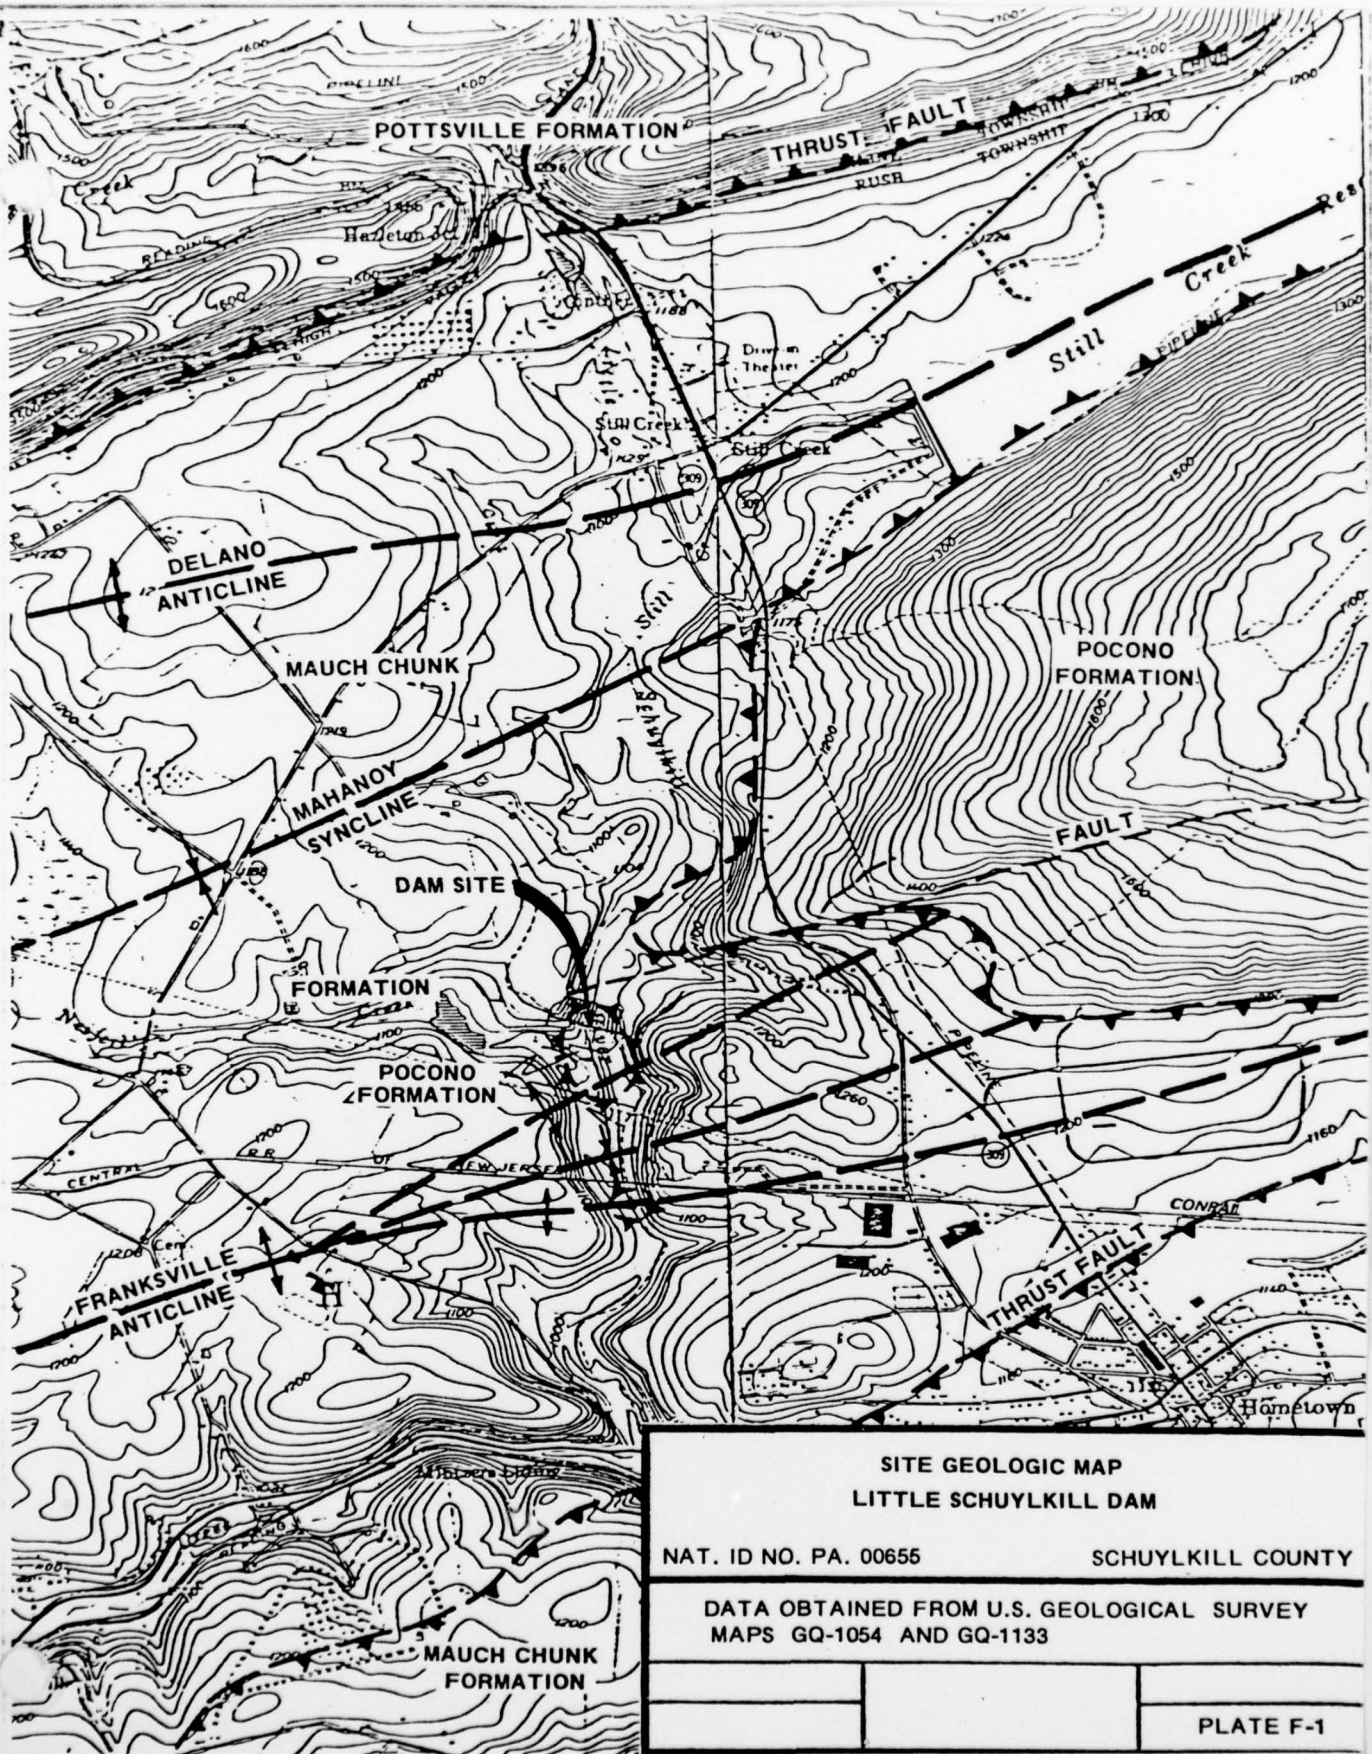
Little Schuylkill Dam is located in the Appalachian Mountain Section of the Valley and Ridge Physiographic Province. As shown in Plate F-1, the dam is located in the sandstone and shale of the Pocono and Mauch Chuck formations of Mississippian age. The entire dam structure is founded in the Pocono Formation except for the right abutment which is underlain by the Mauch Chunk Formation (see Photo No. 4). In the right abutment area, bedrock strikes west-northwest and dips approximately 20 degrees to the south (downstream direction). Jointing strikes northwest and dips 70 degrees to the southwest (downstream direction) (and 65 degrees to the northeast. Another major joint set strikes east-northeast with near-vertical dips to the north.

The dam lies between two regional east-northeast trending folds in an area of localized thrust faulting. Several faults occur in the immediate dam foundation area as shown on Plate F-1. One is a low angle thrust fault with an elliptical fault trace due to erosion which formed the present Little Schuylkill River valley. The other fault which terminates near the right abutment strikes east-northeast with a sense of movement of down-to-the-south.

The combination of southerly dipping bedding and joint planes and faulted terrain would be conducive to downstream water seeps. Problems of water seepage are not considered to be significant since this dam is a flood control structure and is not expected to be at maximum capacity for extended periods.
